**TREE SURVEY**

**OWEN O'CALLAGHAN  
SOUTH OF IRELAND TREE SURVEYS  
1 WESTBOURNE TERRACE  
THE LOUGH  
CORK**

## 1. INTRODUCTION

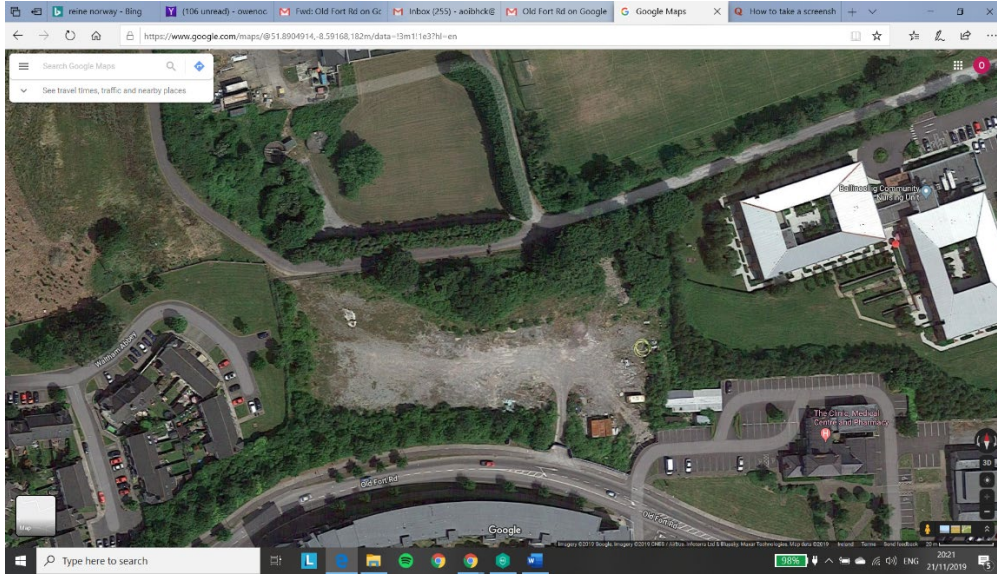
Fig. 1: *Aerial photograph of site*

- 2.1 The site area (highlighted red, Fig. 1) is currently an undeveloped site, located to the north of Ballincollig. Site levels appear to have been raised by a number of metres (3m approximately) over the years.
